# CHAPARRAL CONVERSION AND CULTURAL RESOURCES ON THE PRESCOTT NATIONAL FOREST:

AN EXPERIMENTAL STUDY OF THE IMPACTS OF SURFACE MECHANICAL TREATMENT BY MARDEN BRUSH-CRUSHER

J. SCOTT WOOD TONTO NATIONAL FOREST

CULTURAL RESOURCES REPORT NO. 27

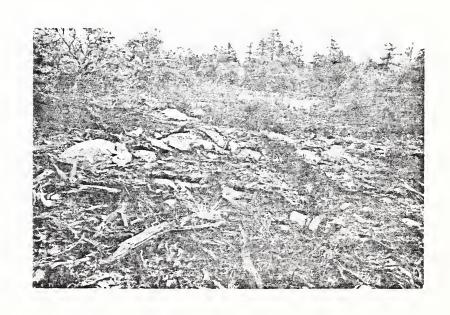
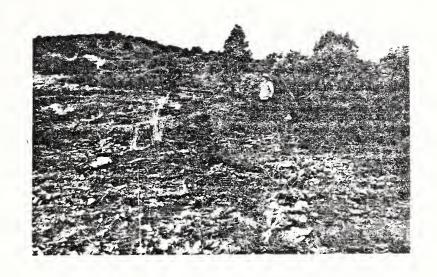
does not consist primarily of high relief exposed bedrock or talus. Rocky surfaces tend to dull and break the blades. Thus, its normal operation will leave a pattern of irregular patches of crushed and uncrushed stands of brush. The effectiveness of the treatment is evident in photographs of a nearby area (Figs. 6, 7, and 8) which was crushed in 1976. In the two years since this area was crushed, the only change that has occurred is the establishment of some grasses. The patterning of the cursh and the features of the surface disturbance remain obvious and the brush has made little in the way of a comeback.

Fig. 6. Surficial Impact of Marden Device, 1976 (Photographed Feb. 1978)

Fig. 7. Surficial Impact of Marden Device, 1976 (Photographed Feb. 1978)

Fig. 8. Surficial Impact of Marden Device, 1976 (Photographed Feb. 1978)

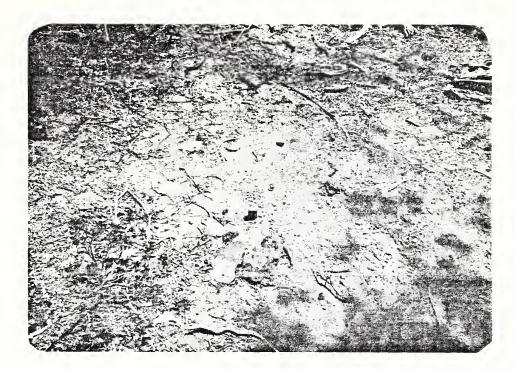
Fig. 61. Oblique View, Control Burial #1 (Layout)

Burial #1 - This control was placed in a fine-textured humus and sandy loam soil with no vegetative cover. The lower set of pots was placed about 35 centimeters deep while the upper set was about 20 centimeters deep with about 5 centimeters of soil over the top. - All pots were set vertically as if on a buried floor and the soil was packed back into the pit to approximately its former consistency. Recovery of the pots after 2 months with periodic rainfall showed no additional compaction or settling of the fill and pit walls were difficult to redefine. This held true in all cases, control and test, indicating that an approximate replication of natural conditions had been achieved (Fig. 61).

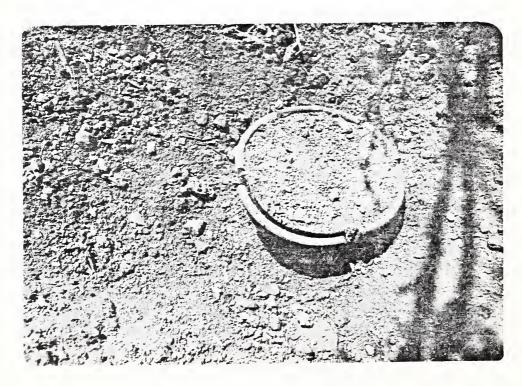
On recovery, the large upper pot was found to be broken by expansion of the clays in the soil. This is clearly seen in Fig. 64, where clay can be seen to have extruded into the cracks it had produced. No other damage to the pots was noted. It is felt that the periodic rain and overnight frosts which occurred between layout and recovery were responsible for the destructive action of the expansive clays. Unfortunately, the expansive nature of the clay was not recognized at the time of the layout.

Fig. 64. Control Burial #2 (Recovery) Showing Pot Broken By Clay Expansion

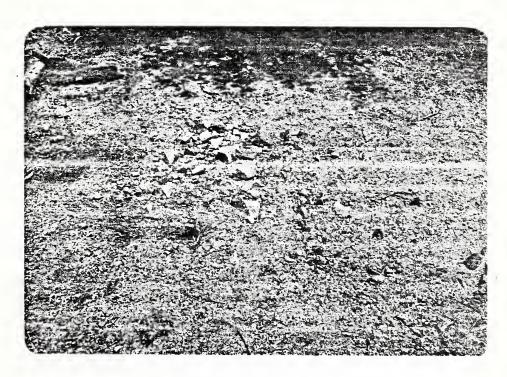
Fig. 66. Oblique View, Control Burial #3 (Layout)

Burial #3 - Dug into a rocky clay-sand soil, this burial again had no brush cover (Fig. 66). The lower set of pots was at 33 centimeters, the upper at 18 centimeters, and the top cover was 3 centimeters. Rocks in the burial pit ranged in size from gravel to about 10 centimeters diameter.

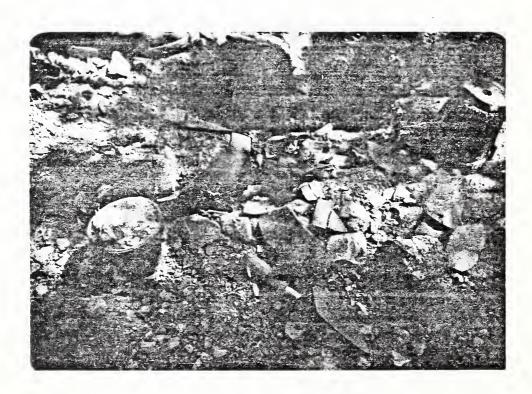
The larger pot in the upper set was broken when recovered, again by expansive clays. The smaller of that set was intact (Fig. 67). Both pots in the lower set were broken into small pieces by the force of clay against rock (Fig. 68).

Fig. 68. Control Burial #3 (Recovery)
Showing Total Damage

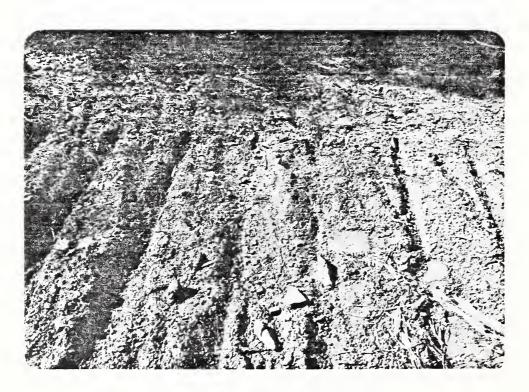
Fig. 72. Oblique View, Test Burial #1 (Recovery) Showing Blade Furrows

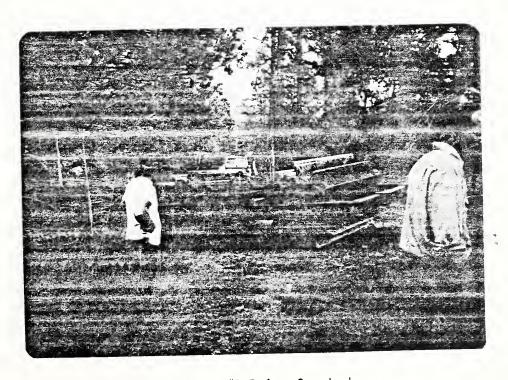
The path taken by the crusher over the test was straight and left distinct furrows with more or less intact strips between them, though mixing in the furrows raised, softened, and fractured the strip surfaces somewhat (Figs. 80 and 81).

Fig. 80. Test Burial #3 Being Crushed

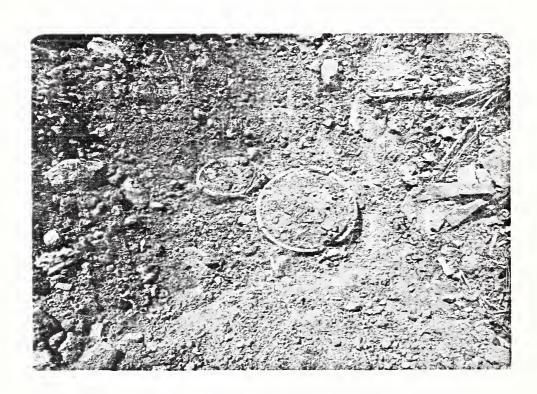
Fig. 82. Test Burial #3 (Recovery)
Showing Upper Set of Pots

No blade contact was made with either set of pots but close blade proximity (Fig. 90e and f) produced breakage of rims in the upper set by the movement of subsurface rocks (Fig. 82). This churning displacement produced some grinding and powdering of sherd edges in the breaks, as at Burial #1. The small pot in the lower set was left intact, but the larger pot also suffered some rock impact breakage of the rim (Fig. 83). Total damage here was the same as at the control burial of this type, though the location of impacts was different. Highest at depth in the control situation, they were highest here near the surface. Again there appears to have been a different mechanism of damage. No clay was present in the test burial and all indications are that the test damage was derived from the crushing. A strongly indicated factor in assessing impact appears to be the percentage of rocks in the soil--a higher percentage would seem to lead to a higher incidence of damage to subsurface materials, regardless of the cause of the impact.

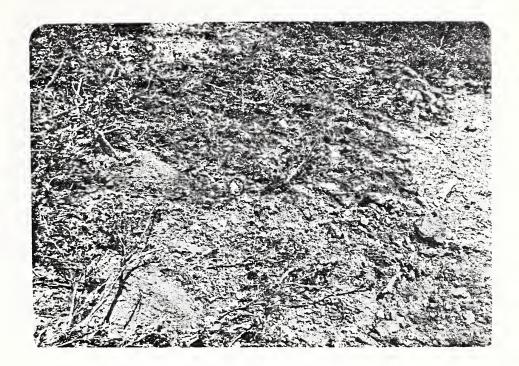
Fig. 87. Oblique View, Test Burial #4
(Recovery) Showing Blade Furrows and Exposed Sherd (Circled)
